Intel[®] StrongARM[®] SA-1100 Microprocessor

Specification Update

May 1999

Order Number: 278105-012

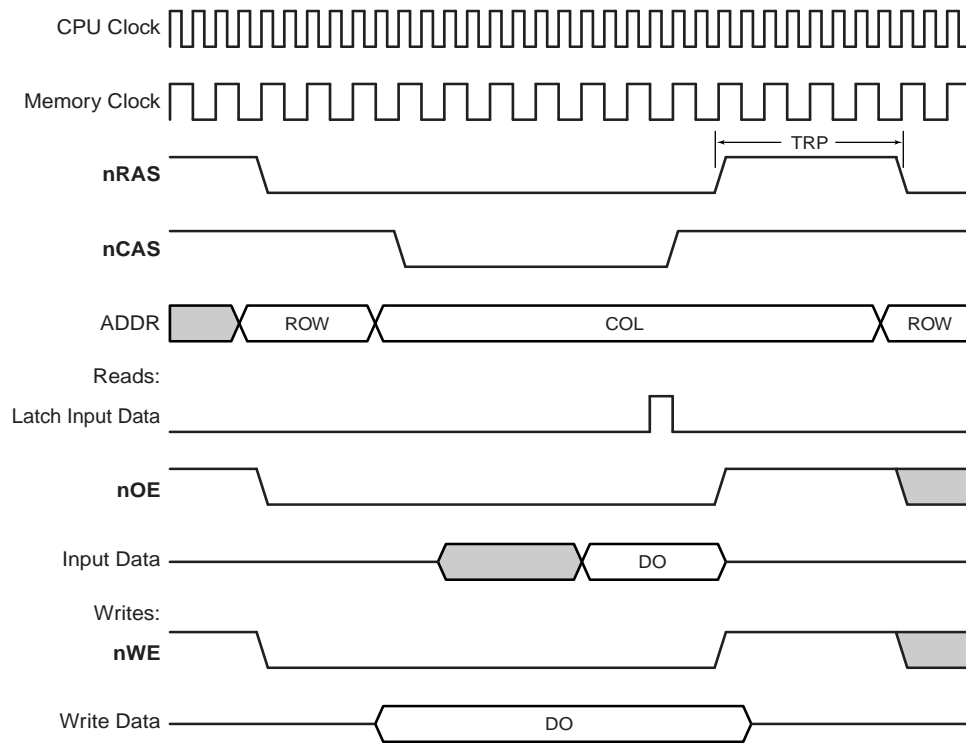
3. DRAM Single-Beat Transactions: Figure 10-3

Figure 10-3 replaced with the following figure:

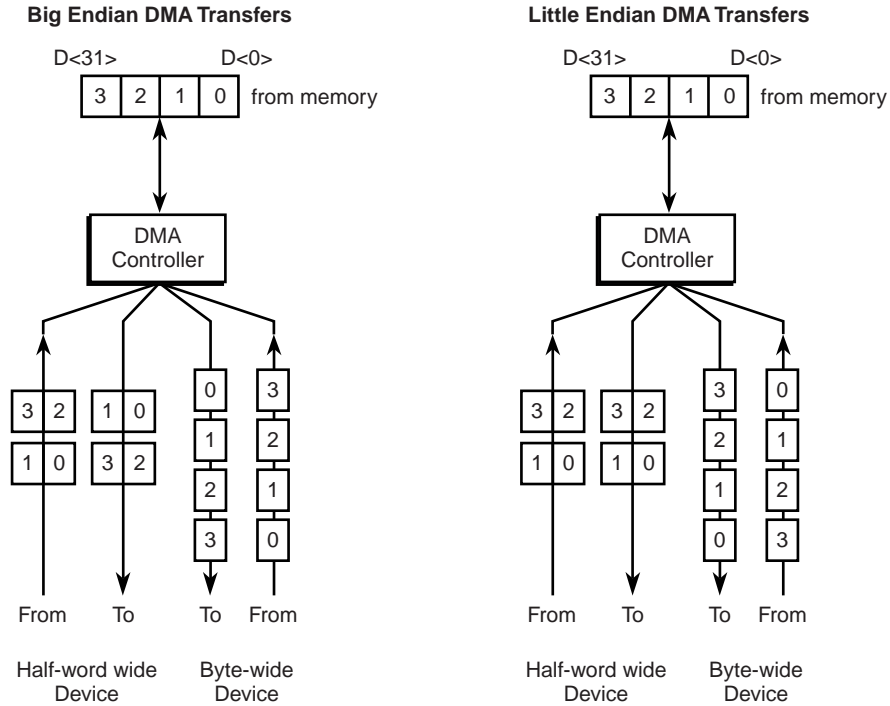
6. **Big and Little Endian DMA Transfers: Figure 11-2**

Figure 11-2 replaced with:

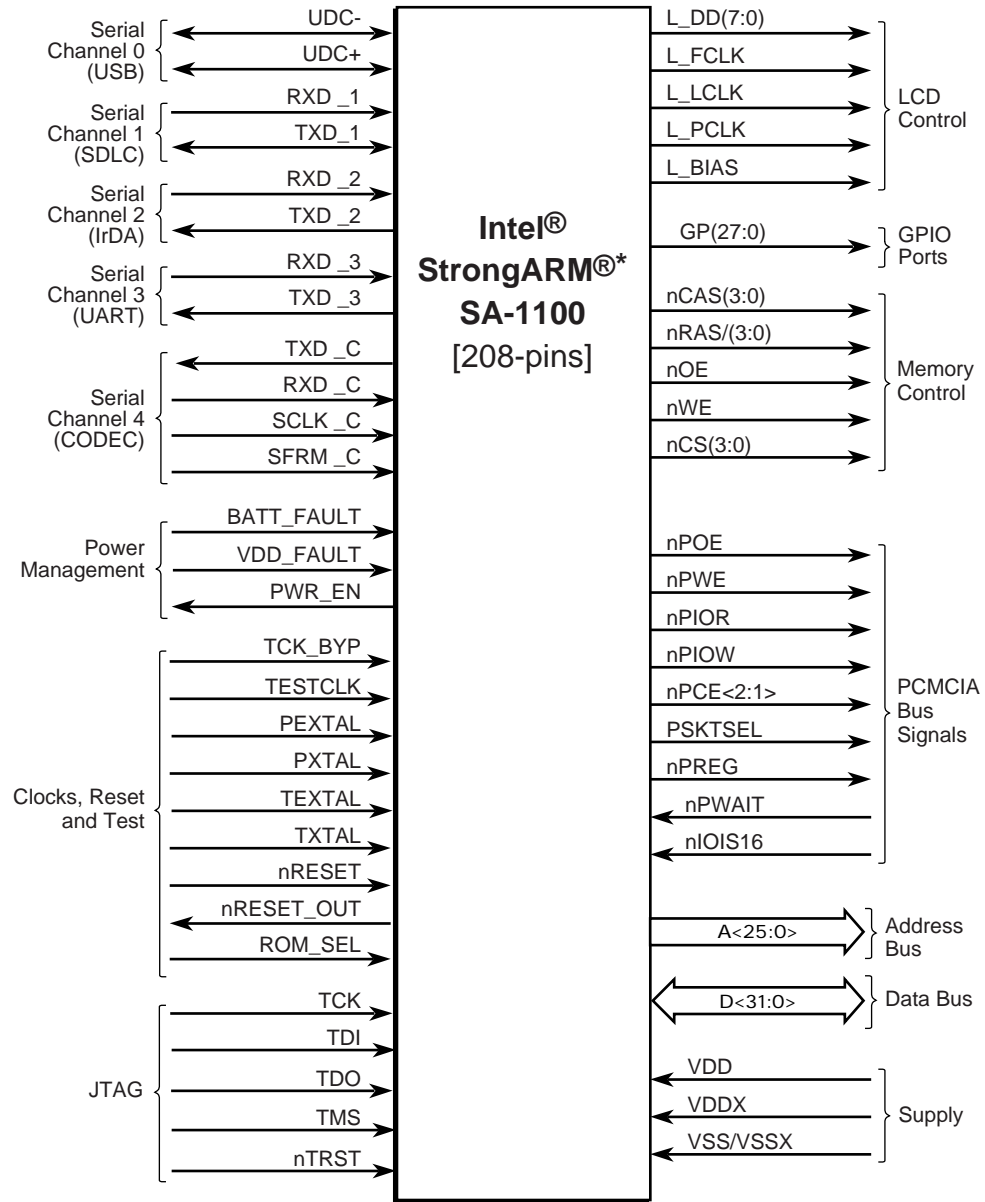
8. SA-1100 Functional Diagram: Figure 2-2

Figure 2-2 replaced with:
